Superior Performance Results

Boiler System:

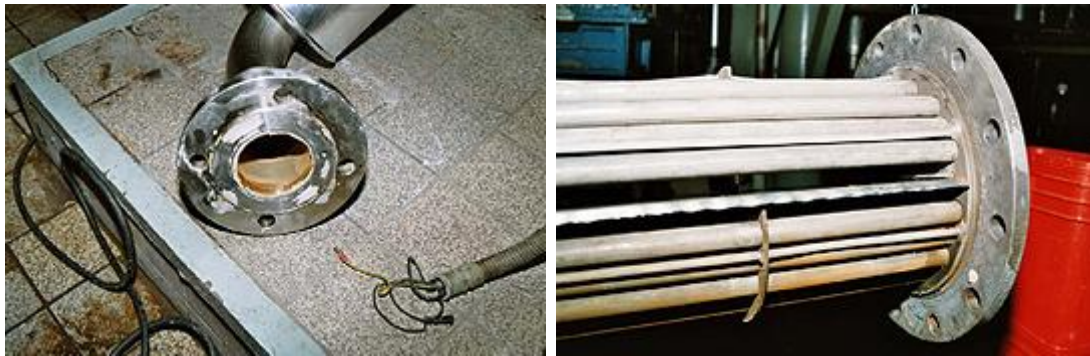
Hot water pipe (left)/ heat exchanger core and stainless steel guide to control internal flow (right)

At the time of these photographs, the boiler had already heated in excess of 80 million gallons of water in its service life. More importantly, the photographs show the heat exchanger after one year of uninterrupted service having heated in excess of 24 million gallons of water since the last annual inspection! This spring (2007) the annual inspections of the boiler were suspended indefinitely. Since the previous two inspections had not yielded any need for cleaning and the system was operating within specifications the owner chose not to bother going forward.

The pictures show the heat exchanger with the insulation removed and the core / heating coil freshly pulled. As one can plainly see, there are absolutely no scale deposits on the element or the heat exchanger pipe. On the bottom of the pipe's interior, there is a small amount of a silt-like deposit of the calcium carbonate crystals produced by the NaturSoft media. The stainless steel surfaces of the heating coil have a slightly dull look which is due to a few micro micron thick haze of "soft scale" during the process. This deposit is easily wiped off with a cloth or flushed away with a pressure washer – without the need for chemicals of any kind. It is the only evidence of hardness minerals that could be found after one full year of operation.

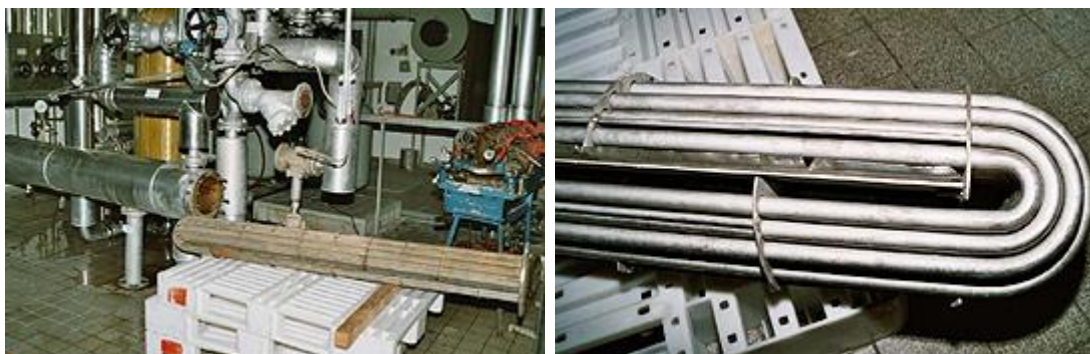
Heat exchanger and core (left) / Heat exchange core (right)

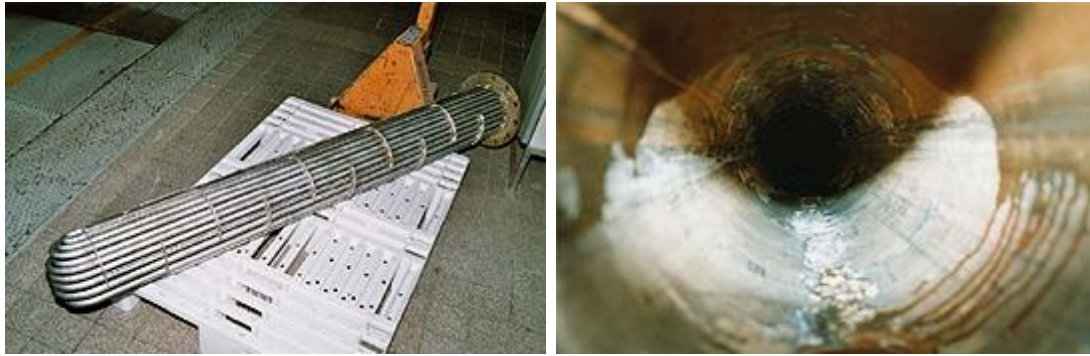
Heat exchange core (left) / inside of the heat exchanger housing (right)
